TECHNICAL PAPER

Corrosion Under Insulation

Mitigating Corrosion Under Insulation (CUI): Spread of corrosion assessment on ArmaFlex® insulation systems in a continuous salt-water spray environment. **A test conducted by TNO/Endures.**

Spread of corrosion assessment on ArmaFlex® insulation systems in a continuous salt-water spray environment.

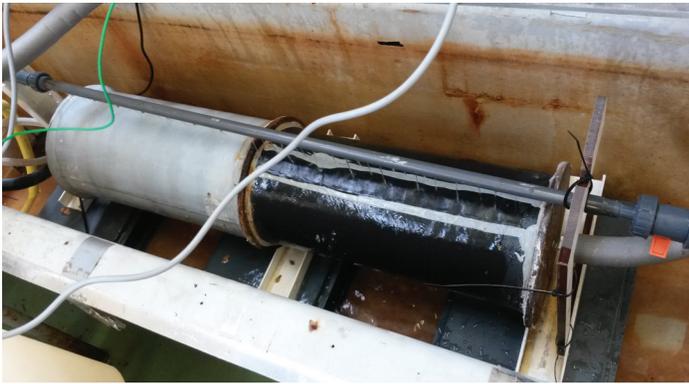
Figure 2: The test setup. Pipe A is on the right and pipe B is on the left.

As with pipe A, two layers of HT/ArmaFlex Industrial insulation were applied to the pipe with ArmaFlex expansion spacers added to the 2nd layer (9 mm thick). The expansion spacers were introduced to mimic insulation systems installed with rigid covering in a real offshore facility. In this case a glass reinforced plastic (GRP) external weather barrier was used to cover the insulation. Holes were again drilled on the top of the insulation system and underneath but this time through the external weather barrier only. The insulation was left undamaged.

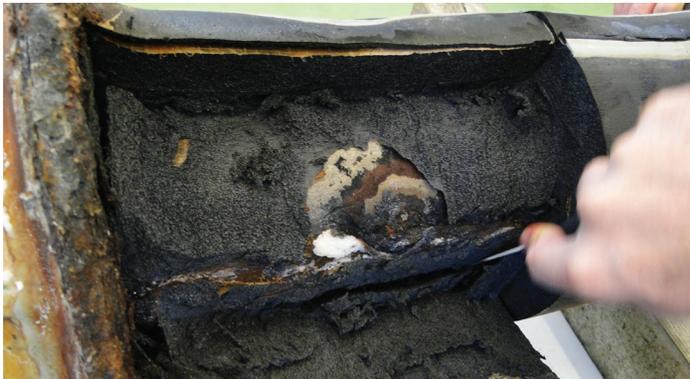
Figure 3: Insulation layers (dark grey) and adhesive layers (brownish) – corrosion localised only to the immediate areas around the holes drilled into the insulation.

However, as the following images reveal, where corrosion occurred this was limited to the immediate areas around the holes drilled on the top of the pipe (at 2 and 10 o'clock).

It is important to note that it is the heating of the adhesive used by Armacell (from the 80 °C of the water in the pipe) that has caused the general brown discoloration of the pipe surface – it is not the result of corrosion.

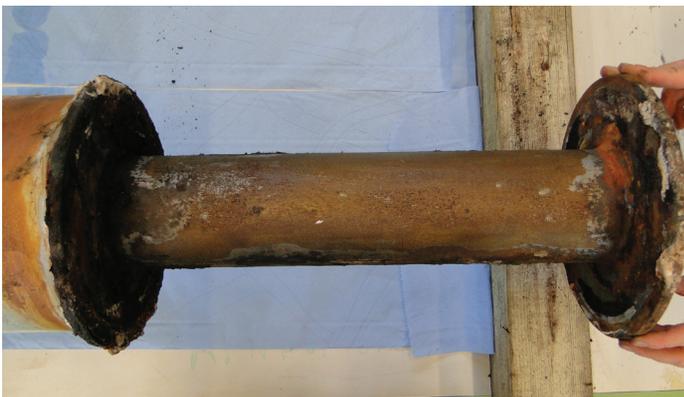
Figure 4: Image of the lower (under) side of the pipe.

Notably, the underside of the pipe shows no sign of corrosion development (see Fig. 4). This means that no salt water reached the lower part of the pipe. The test institute concluded that this was due to the vapour barrier properties of the adhesive used by Armacell and of the ArmaFlex (closed-cell FEF) material. **The Institute says:**

“No significant corrosion is observed in this area, which means that no salt water reached the lower part of the pipe through the holes and this can be attributable to the barrier properties of the good adhesive and the closed-cell FEF insulation material.”⁵”

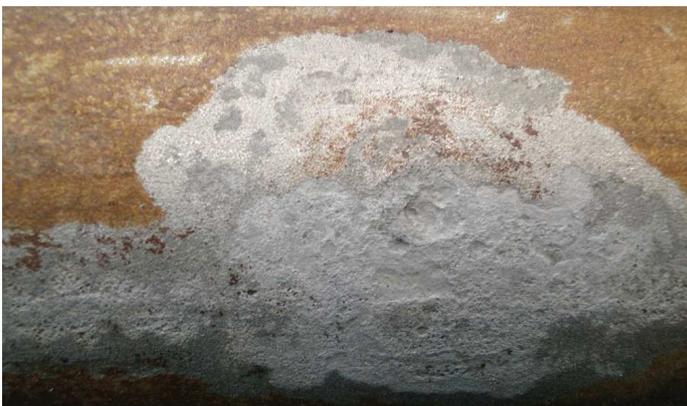
Figure 5: Close-up of the deepest area of the localised corrosion (pipe A).

Given the extreme conditions of the test, it was inevitable that some localised corrosion would take place. A key part of the investigation was to look for the spread of corrosion outside of the damaged areas. The test demonstrated that corrosion was contained to the damage area and did not spread to the underside of the pipe, with limited lateral spread.

The lack of corrosion spread was put down to the barrier properties of the ArmaFlex, closed-cell FEF insulation material. **This performance was surpassed by pipe B.**

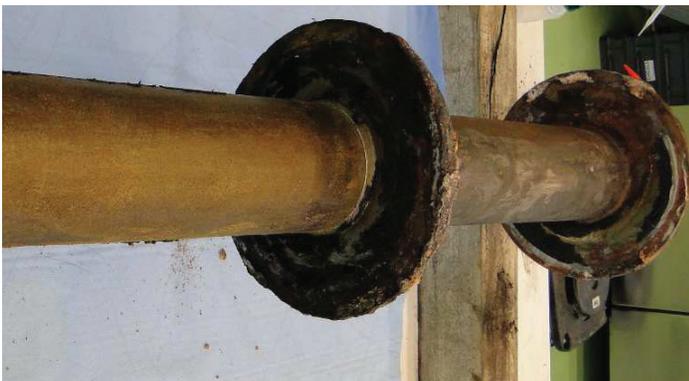
Figure 6: Pipe B with no corrosion.

With pipe B, the drilled 5 mm holes only penetrated the protective cladding. During the removal of the insulation it was noted that the outer layer of insulation was damp to touch. However, the inner layer remained completely dry. In its report the institute said:

“The outer layer of the insulation materials is wet but the inner insulation is still dry which is attributable to the barrier adhesive layer between the two insulation layers. No corrosion has been observed on the steel surface.”⁵”

The test laboratory noted that the 5 mm hole on the underneath side of the weather barrier (protective cladding) had become blocked and water had pooled between this barrier and the insulation. However, both here, and across the whole pipe, the institute reports that:

“No corrosion has been observed on the steel surface.”

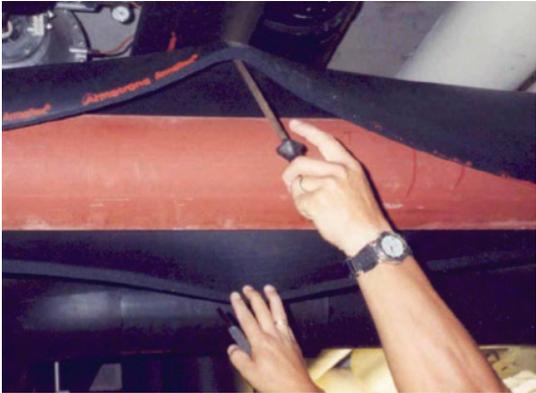
Figure 7: This cold water pipeline has been protected by Armaflex for 20 years - the picture shows maintenance inspection of the original system.
